## Sandy

### Accessibility Solutions

After living with Multiple Sclerosis for 28 years, and adopting 15 children, as well as taking in foster children for 34 years, Sandy and her husband needed to build a house that was accessible for her needs as well as big enough for all of their children. Everything in the house was designed specifically for Sandy so that she could use every room in the house.

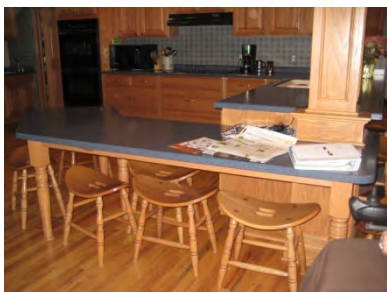
Figure 1

**Kitchen:** The kitchen is the first room you see when you enter the house. It has a lot of special features in it that were designed for Sandy's convenience. First there is a breakfast bar that wraps around in an 'L' shape; one side is slightly lower than the other so that Sandy can wheel right up to it. They bought matching stools that are at two different heights that sit under the breakfast bar (Fig. 1). There is also a spot cut out of the counter that Sandy can wheel under and work, however they don't use it very often and instead use it as a place to set their Great Dane's food and water (Fig. 2). Drawers were installed all over the kitchen instead of traditional cupboards so that Sandy can reach items more easily (Fig. 3). The oven is built into the cabinetry so that she can easily reach it (Fig. 4). She also has a large pantry built right off of the kitchen; the pantry is big enough for her to roll into it in her wheelchair (Figs. 4 & 5).

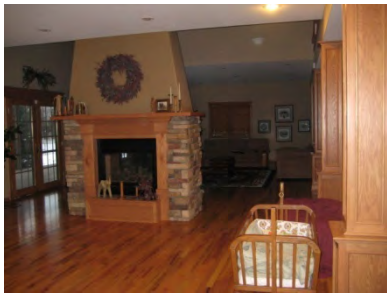
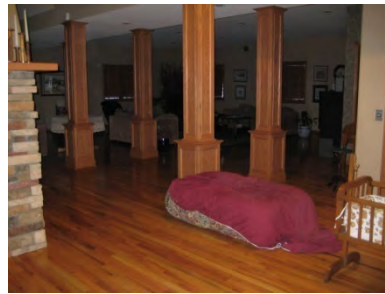
**Living Room:** The living room was built with an open space plan so there is plenty of space for the entire family and Sandy can wheel around freely (Figs. 6 & 7). The windows were placed at a lower level so she could look outside and see more than just blue sky and the tops of trees (Fig. 8). There is also an elevator that runs from the basement to the second floor (Figs. 9 & 10). Since there are few walls in the living room, the light switches (all rocker switches) are located on the support beams (Fig. 11). Sandy also had the thermostat lowered on the wall so she can reach it (Fig. 12).

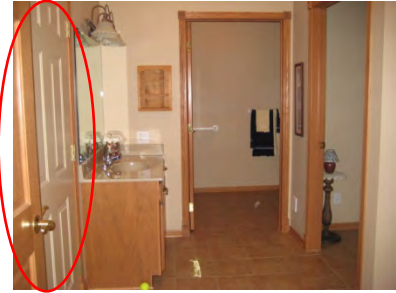
Figure 15

This bathroom has extra space built in so her lift can be stored on the main floor (Fig. 13). It also has several compartments inside the bathroom (Figs. 14 & 15) leading to the toilet (Fig. 16) and the roll-in shower (Fig. 17). One of the doors in this main floor bathroom leads to the garage

(red circle, Fig. 15). The separate compartments with doors to the toilet and the shower help maintain privacy.

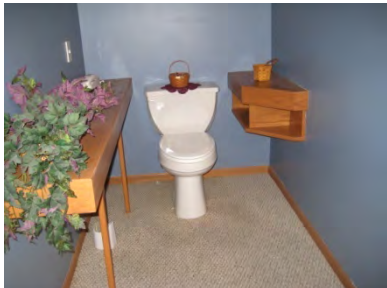
Figure 18

Sandy did have some problems with this bathroom after it was built. In her old house she had a counter that she could lean over and use during her transfer from her wheelchair to the toilet. Unfortunately, the contractor didn't understand what it was that Sandy needed and she cannot lean over this counter as she would run into the wall (Fig. 18). That is the biggest complaint that she has with the bathroom. There is also a nice big roll-in shower included in this bathroom as well (Fig. 19). Sandy and her husband plan to take out the wall that separates the toilet from the shower to fix the transfer problem so going to the bathroom won't be a problem for Sandy. The space that has been cut out under the sink is wider than the area that the sink occupies so that she can wheel over to the side and sit in front of the counter (Fig. 20).

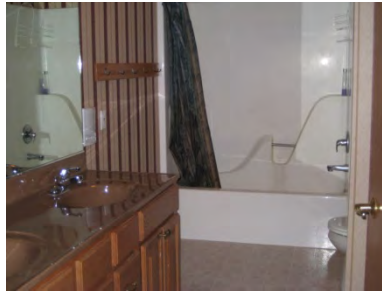
Figure 21

This one is the smallest of the four bathrooms and is for the children who live upstairs. It is large enough that Sandy can wheel around in it, and is the only bathroom in the house that has a tub that Sandy can't use (Fig. 21).

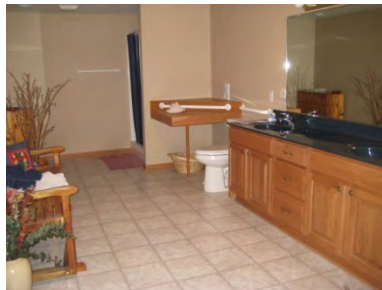
Figure 22

This bathroom has a lot of extra space in it. They didn't need as many rooms in the basement, so they used some of the extra space to make an extra large bathroom (Fig. 22).

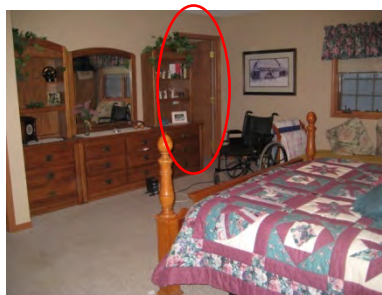
Figure 23

**Bedroom:** Sandy and her husband made sure to include plenty of room in their bedroom for her to get around in her wheelchair (Fig. 23). Sandy has roughly seven feet between her side of the bed and the wall, and roughly eight feet between the foot of the bed and the dresser. They have a large roll-in closet (red circle, Fig. 23) and bathroom attached to the room. There is enough room in the closet for Sandy to wheel her chair in and out and with clothes hanging on both sides.

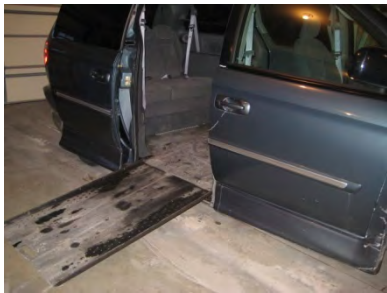
Figure 24

**Vehicle:** Sandy and her husband purchased a wheelchair accessible van that has “kneeling” suspension. The passenger side of the van lowers toward the ground to reduce the incline for the ramp (Fig. 24). The van has automatic doors and an automatic ramp. Also, the passenger seat in the van has been removed so Sandy can sit there in her wheelchair (Fig. 25). The driver’s seat can also be removed in the event that Sandy would be able to drive the car using controls. Sandy and her husband also built a ramp in the garage that leads into the house (Fig. 26). Note that an edge strip needs to be attached to the ramp to keep the wheelchair from rolling off the edge.

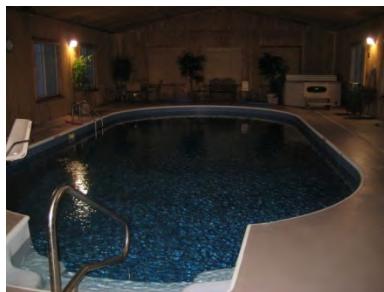
Figure 27

**Pool:** Attached to the house is an enclosed, heated pool so that it can be used year-round (Fig. 27). The pool goes from three feet deep to five feet deep. It also has a chair built into the pool so Sandy can sit on it and pivot out over the water and then lower herself into the pool (Fig. 28). She also uses the pool for physical therapy which. In addition, there is a hot tub inside the pool room that Sandy and her family use.
